# Installation Instructions

## for Set # 3.3191

### 63-82 Corvette

# ENERGY

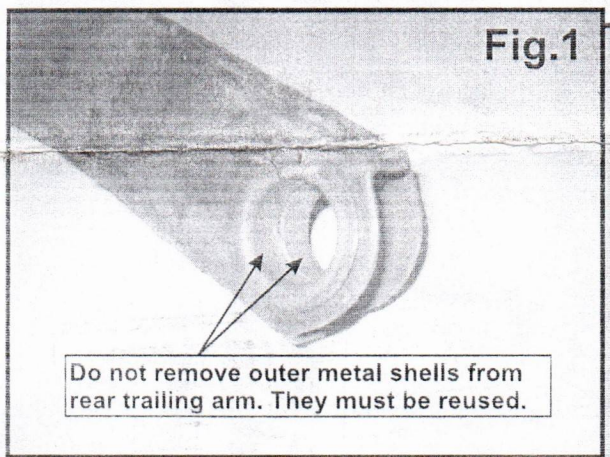
- Note: Do not remove outer metal shell that is pressed into the trailing arm. See Fig. 1 This outer metal shell must be reused!**
3. Clean inside of inner metal shell of any old rubber or rust. When installing polyurethane bushings, apply grease as instructed: Apply light coat of grease to I.D. of the metal shell. Apply light coat of grease to the I.D. and O.D. of bushings (all surfaces that contact metal). Apply light coat of grease to the O.D. of sleeve. Apply light coat of grease to the faces of the bushings before the cap washers are installed.

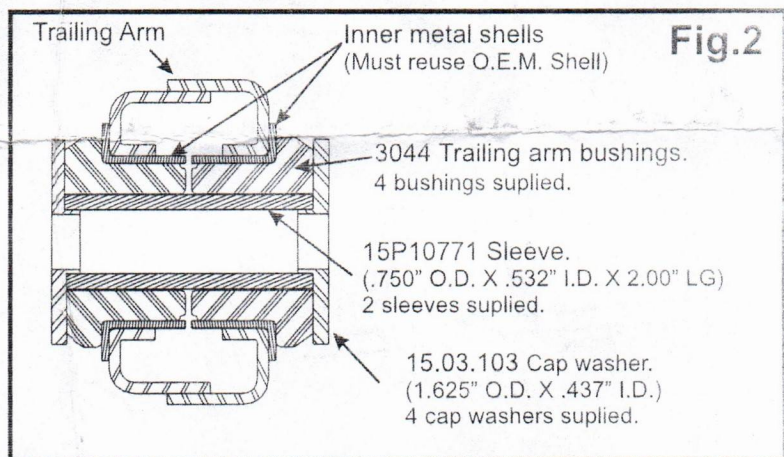
4. Refer to (Fig. 2) for assembly of your new polyurethane bushings.
  5. After applying grease to all necessary parts, use a press or vice (Fig. 3) to install the cap washers into the inner sleeve. The cap washers are not a press fit, the excess grease will help hold the cap washers in place. Be sure to have the cap washers square with the new inner sleeve when assembling together (Fig. 4).
